# Geothermal Steam Field

## Geo Steam Field P Site Well Casing Deformation

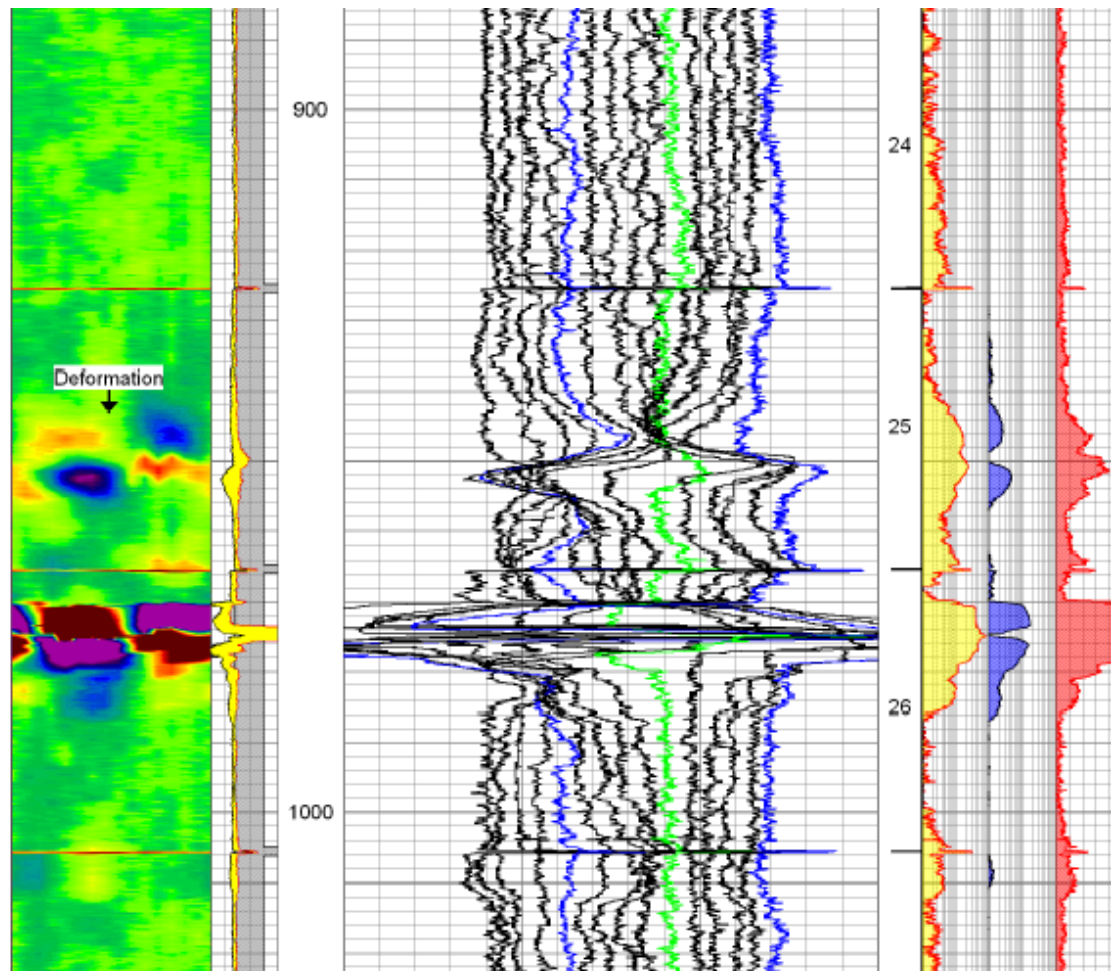
## Well P-1

- In 2017, other P wells were surveyed: P-1 and P-7 wells were also deformed
- The deformation of the P-7 was the most significant found to date as we were unable to get a 6" diameter ring gauge through the bad area of a 12.3" ID casing.

Typical casing deformation of P-site wells

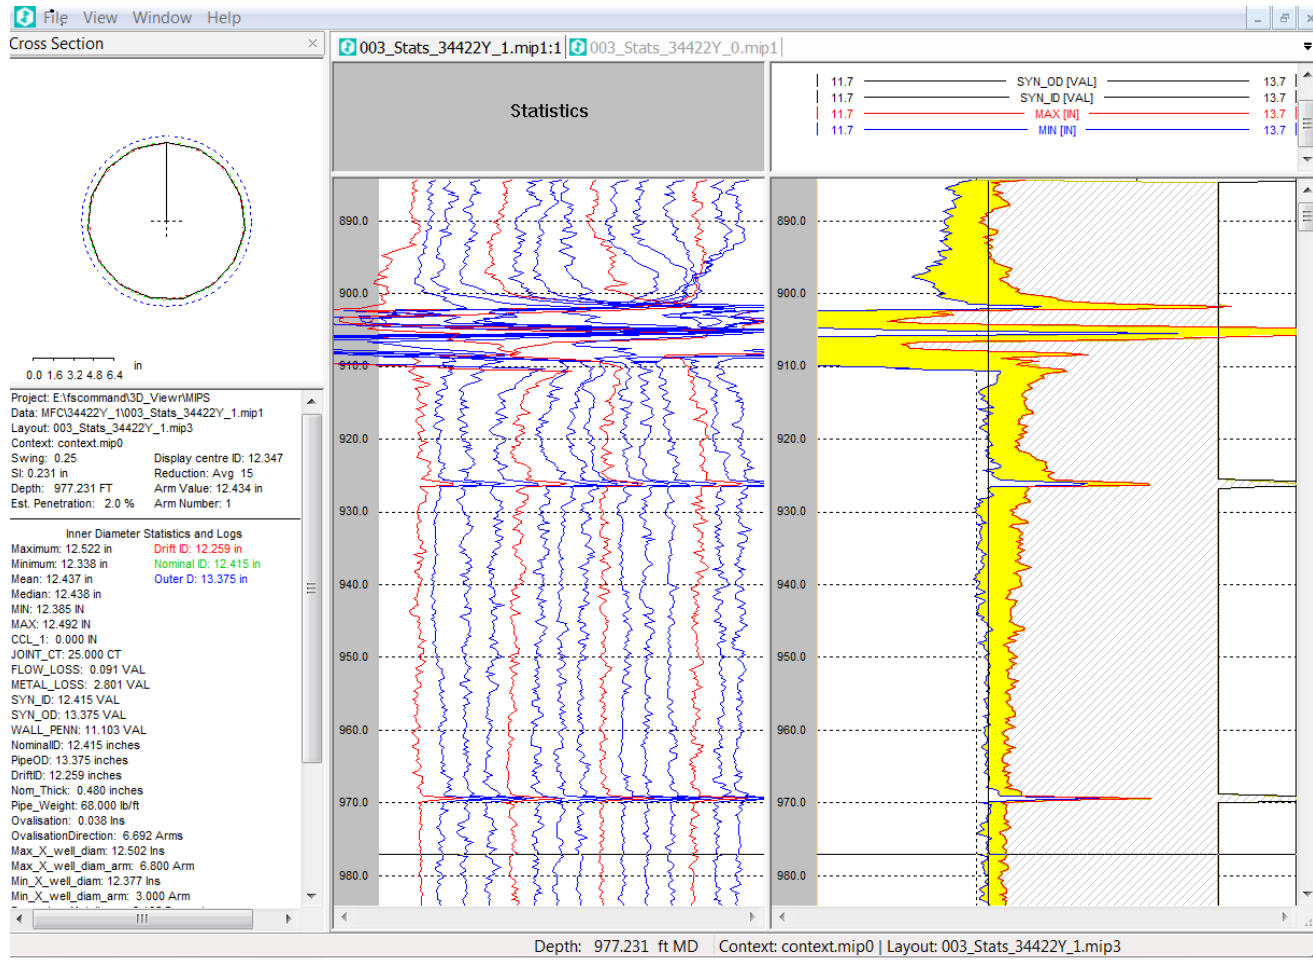
## Production Well P-4, June 2016

# Production Well P- 4, June 2016 Deformation is consistent with every well logged on P-Site

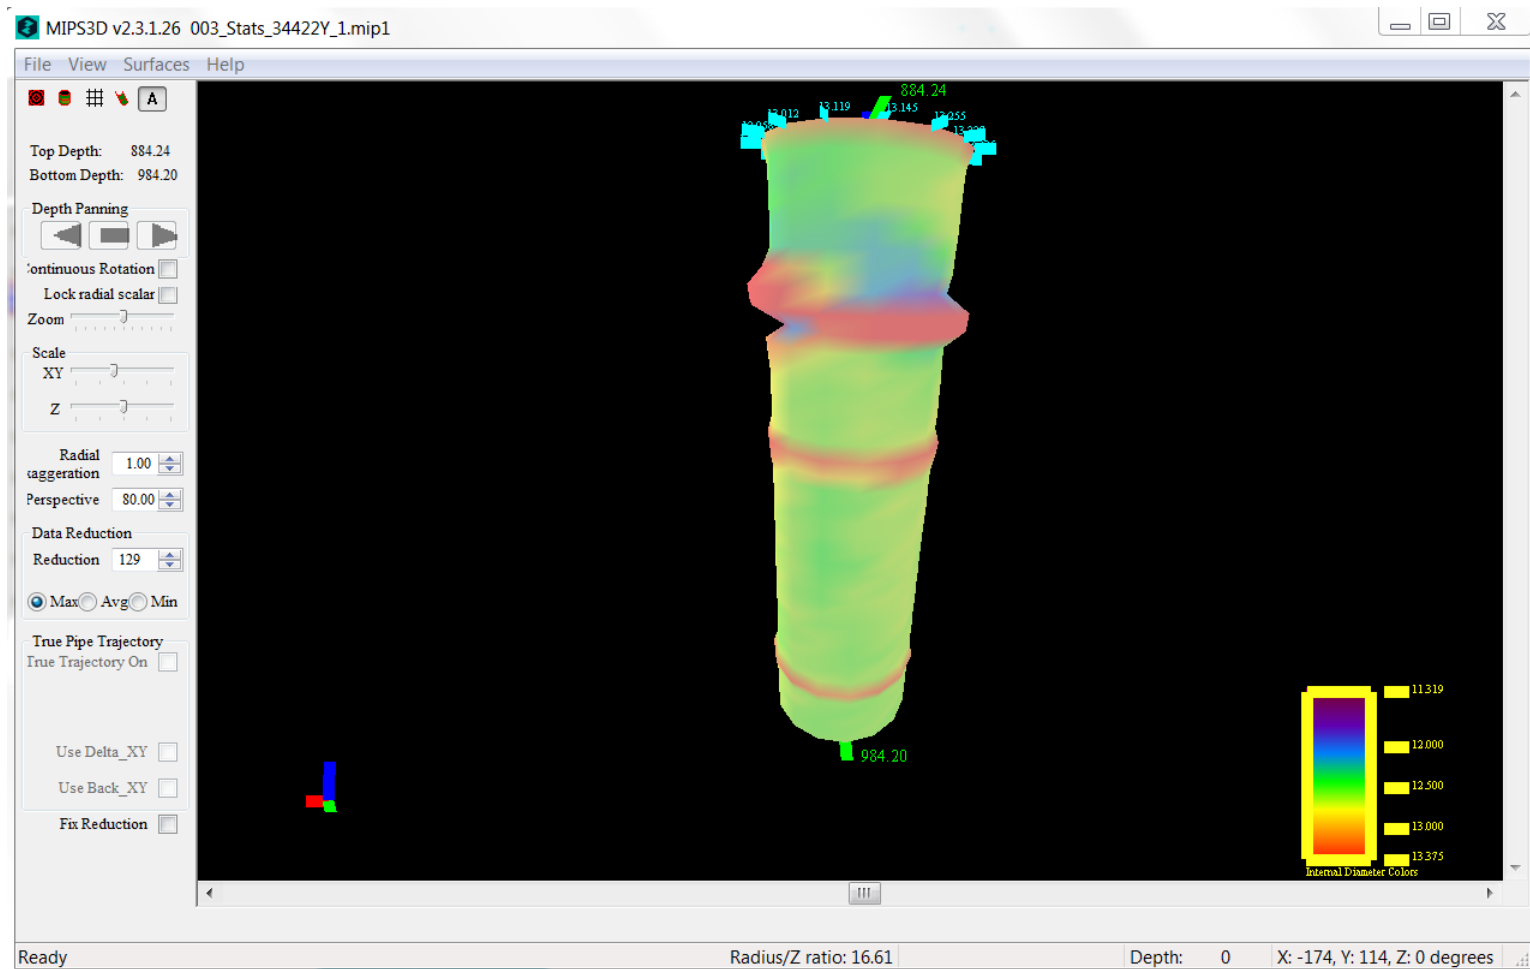
### 3D Rendition of the same deformation as the previous slide

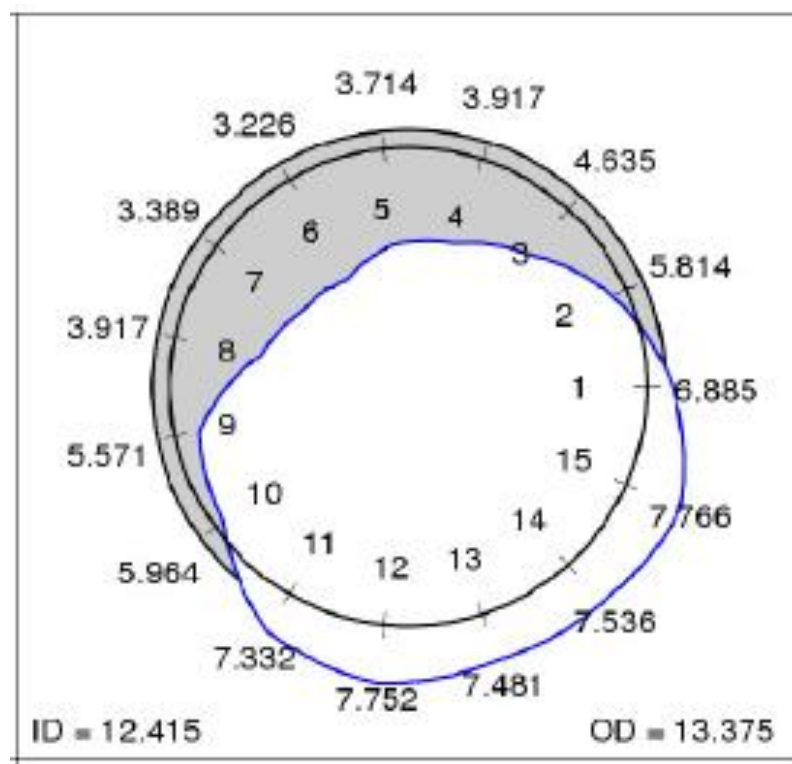
## Comparison of Calculated Flow Loss in well P-4 The same deformation zone as previous two slides

**June 2016**  
**25% Flow Loss**

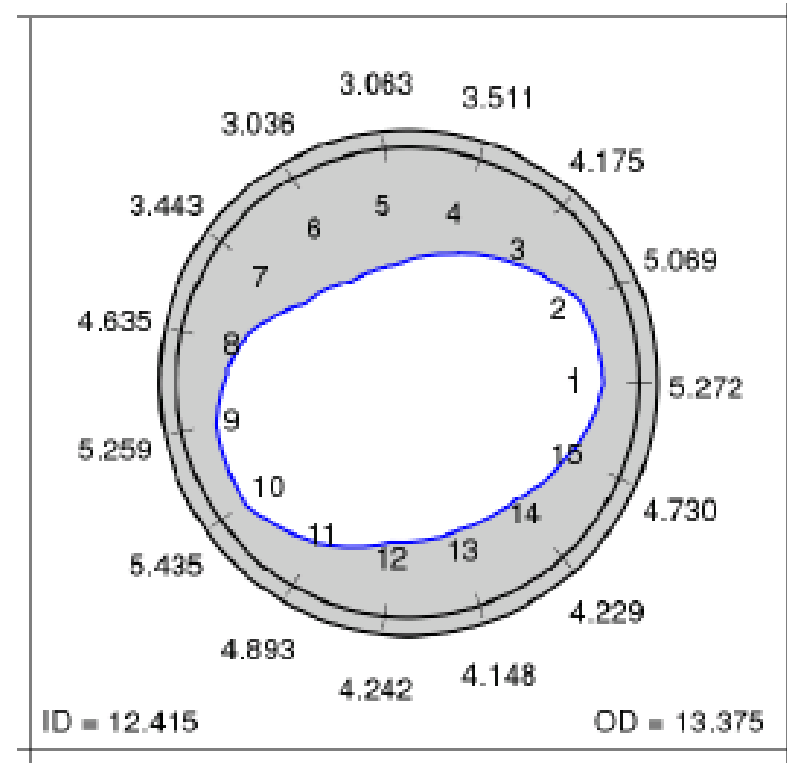
**June 2017**  
**49% Flow Loss**

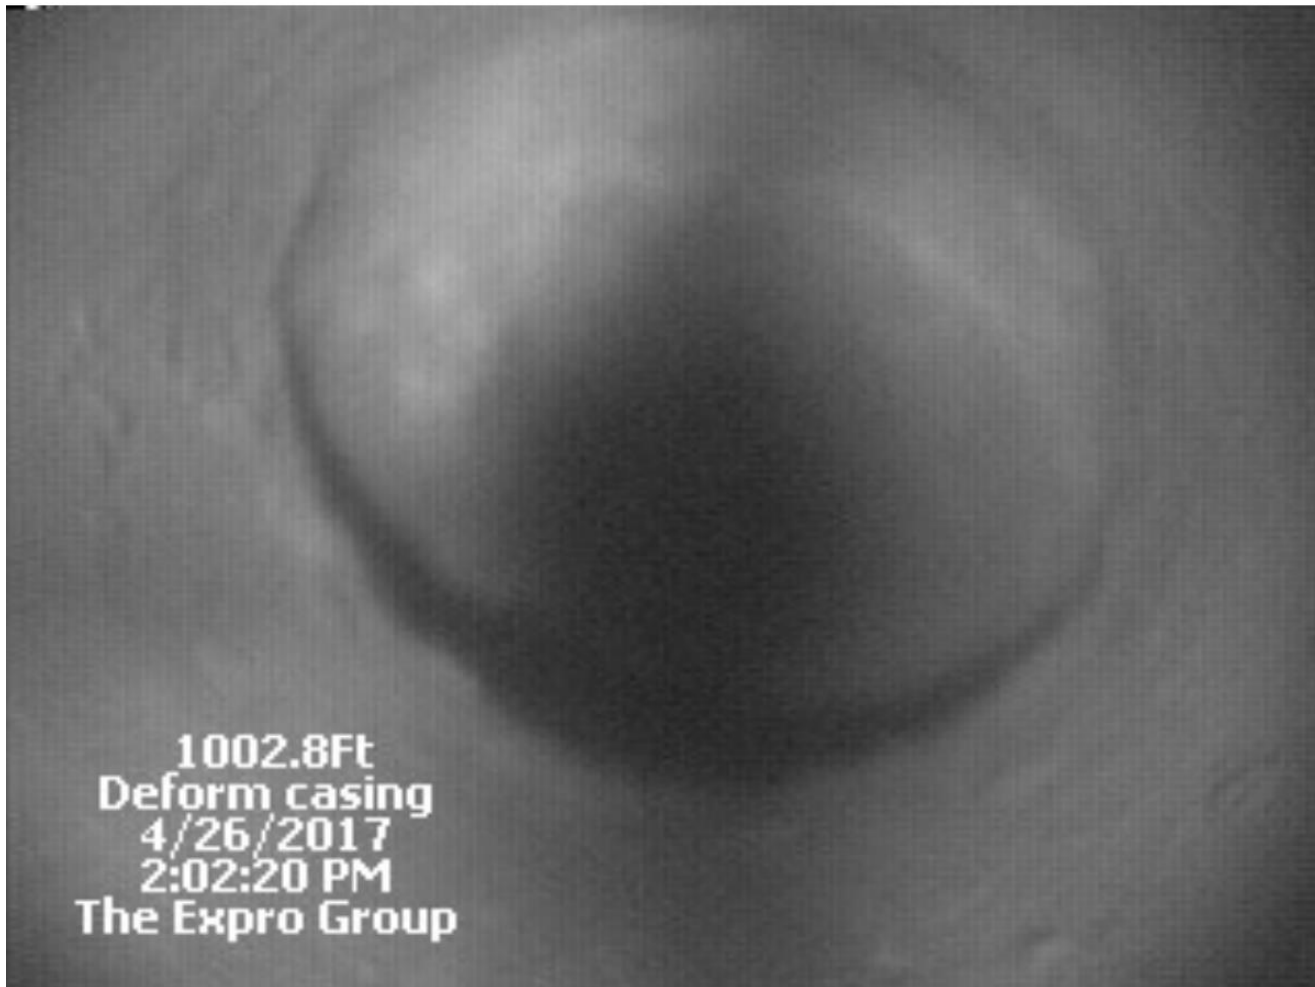
**A camera was used to investigate P-1 and revealed a severe “dog-leg”.  
Note how far off-center the camera is pushed**

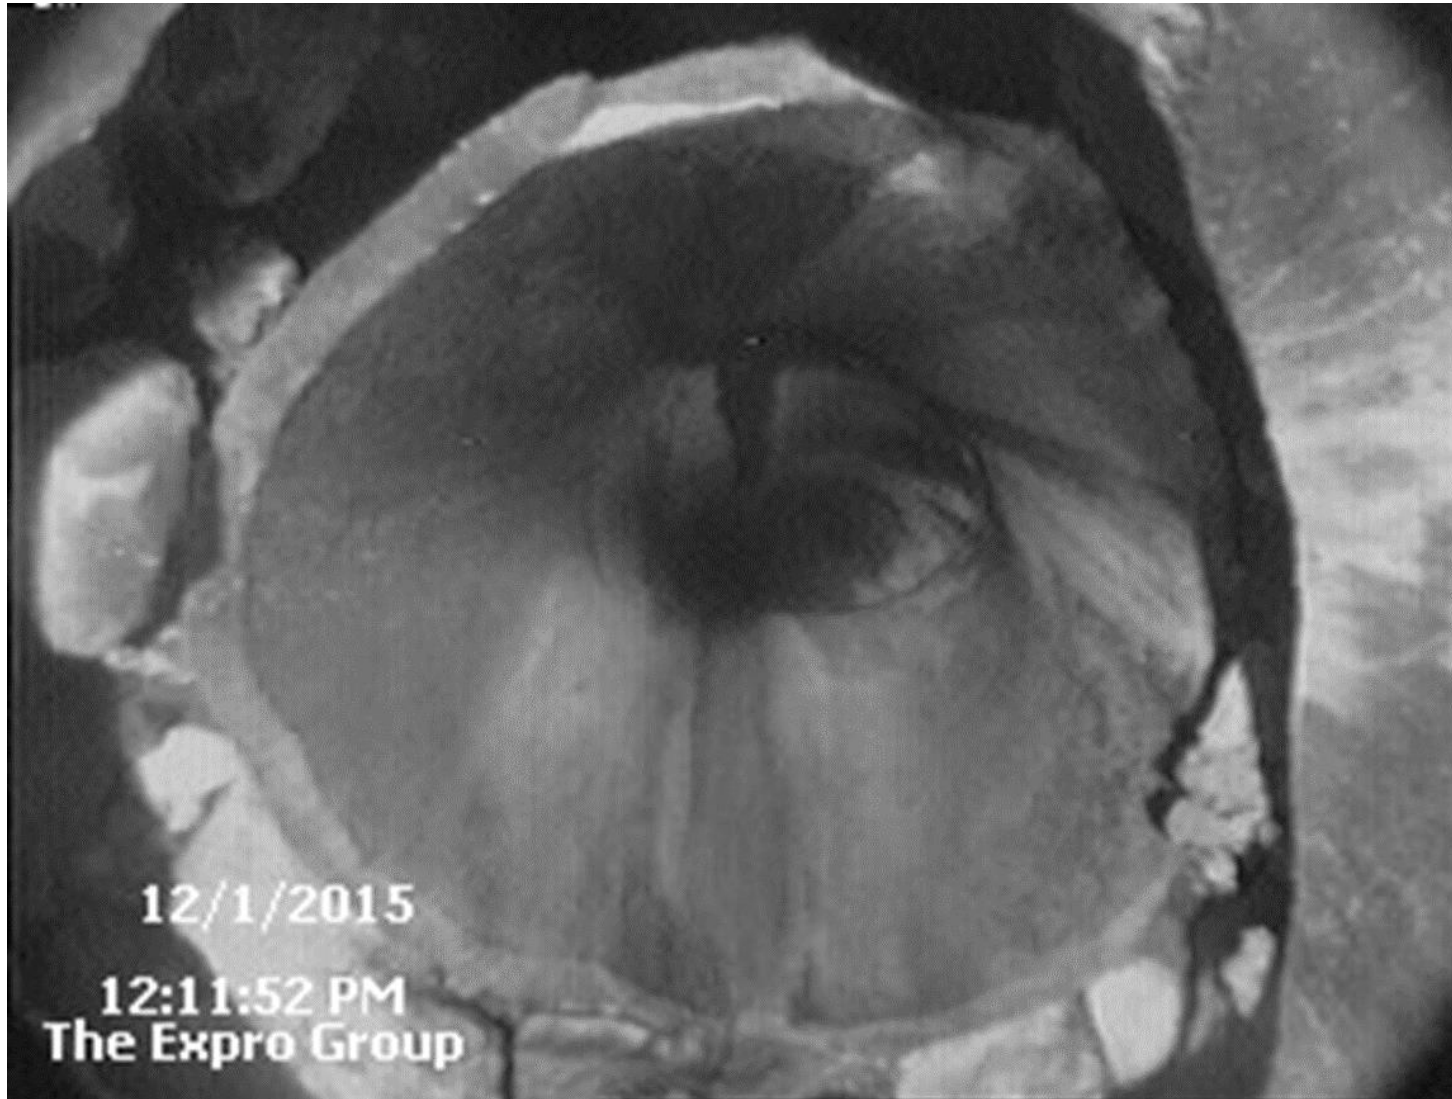
## Injector P9-Parted Casing

- In 2015 & 16 two other P Site wells were calipered and both had deformation in that same depth interval and showed well P-9 had deformed AND parted casing at 980', forcing us to discontinue injection into the well

- Repair for the damaged casing can be problematic: The greater the loss of minimum ID of the casing, the less likely that a repair of the original hole is possible
- Repair methods require a drilling rig, various shaped swedges and mills to attempt reopening the well bore
- If the casing can be opened up, a smaller casing would be cemented inside the existing casing establishing casing integrity-  
Cost~1.5million
- If that repair is not possible: We would plug the well back, mill an opening in the casing above the damaged zone and re-drill the well  
Cost ~ 4.5 million
- Before starting any of this work, a financial analysis for both case scenarios would be completed to determine the appropriate course of action, if any
