Geothermal Steam Field - Well Status

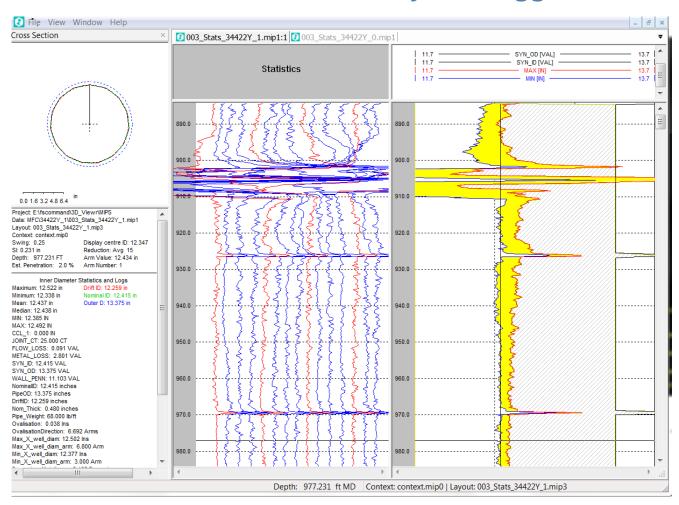
Production Well P- 4, June 2016 Deformation is consistent with every well logged on P-Site

- Well Workovers are problematic.
 - Greater the damage, less probability of success
- Repair methods
 - Swedge or mill casing, then line with new casing
 - Set cement plug, sidetrack and re-drill
- Workover costs range \$2 to \$6 million

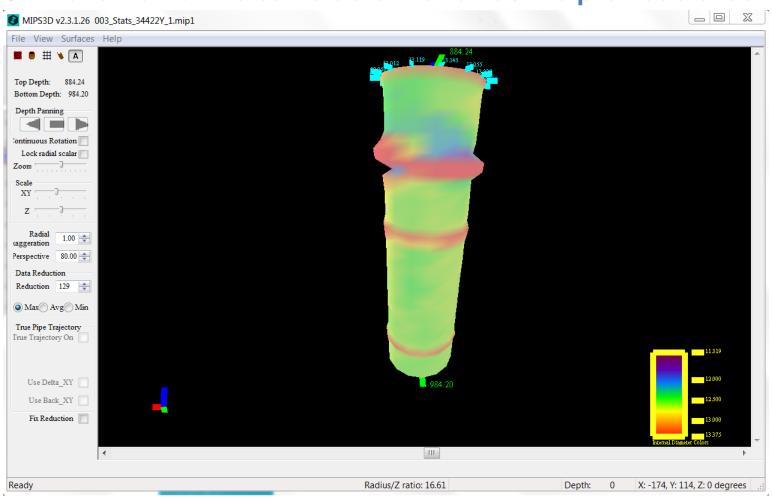
Production Well P-4, June 2016 3D Rendition of the same deformation as the previous slide
