Erosion at Adit 4 Tunnel Spoils Disposal Site North Fork Stanislaus River Hydroelectric Project

February 3, 2016
Facilities Committee Meeting

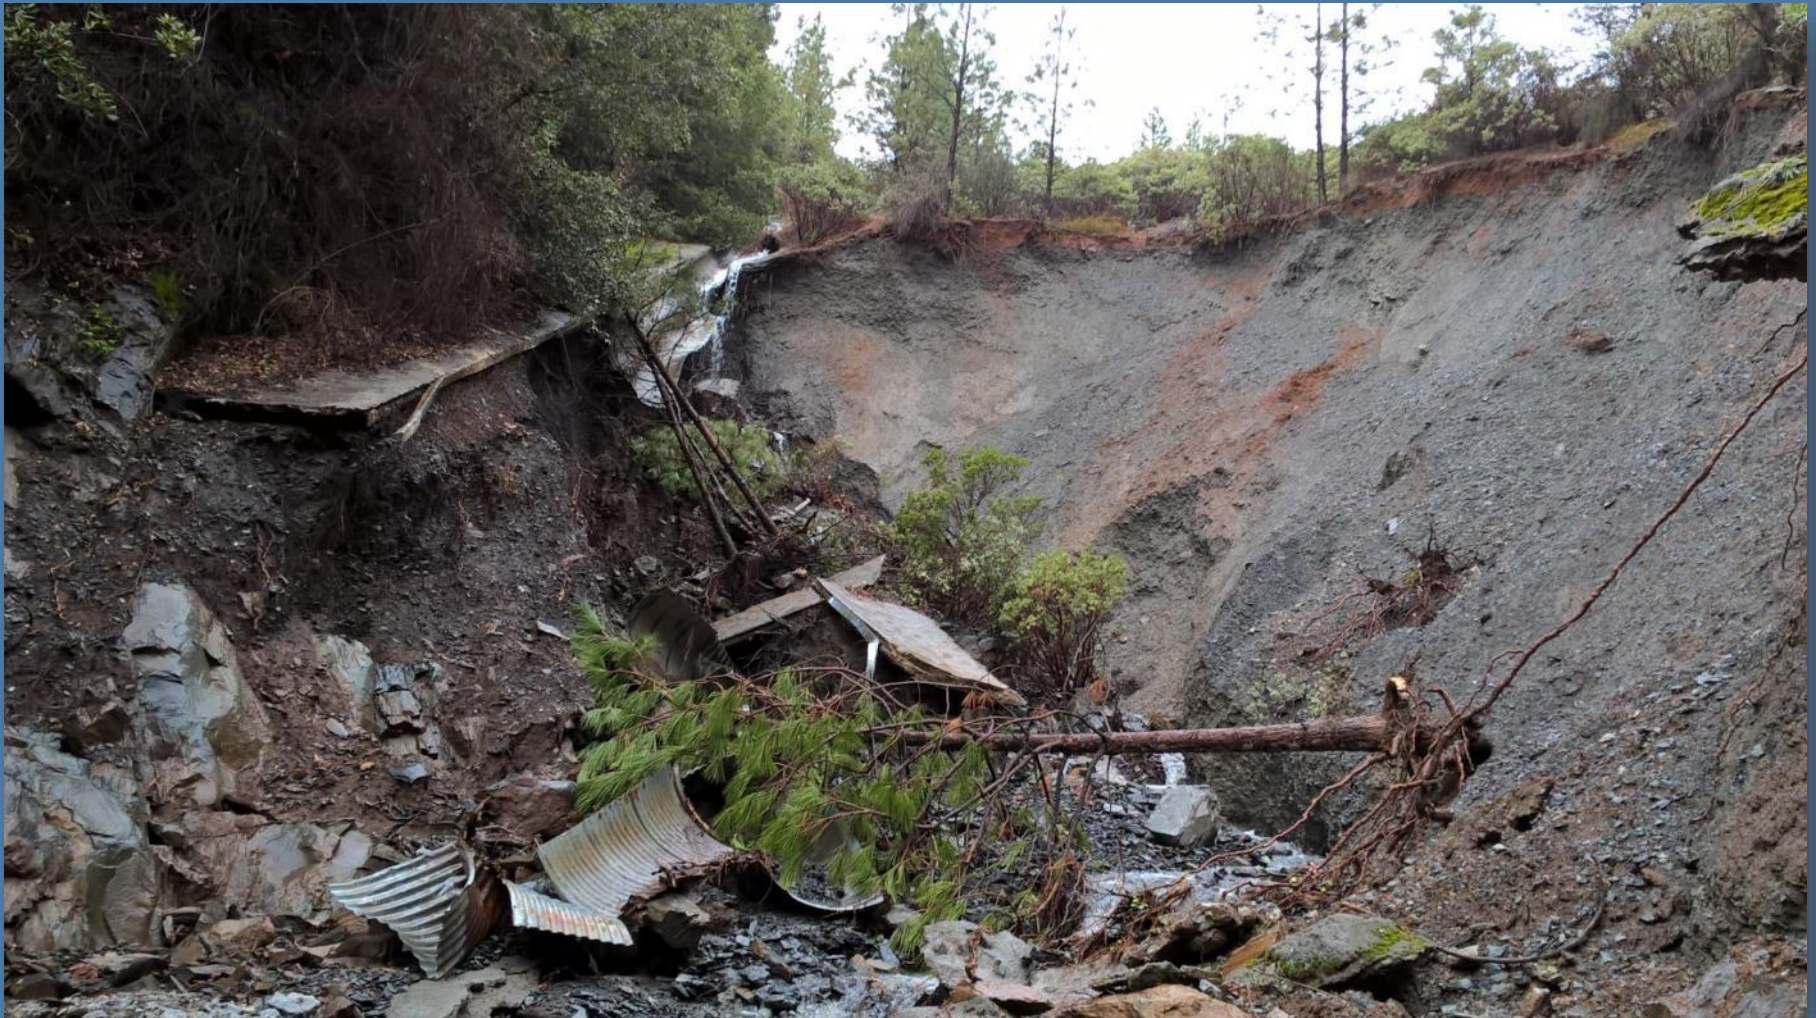
Spoils Erosion

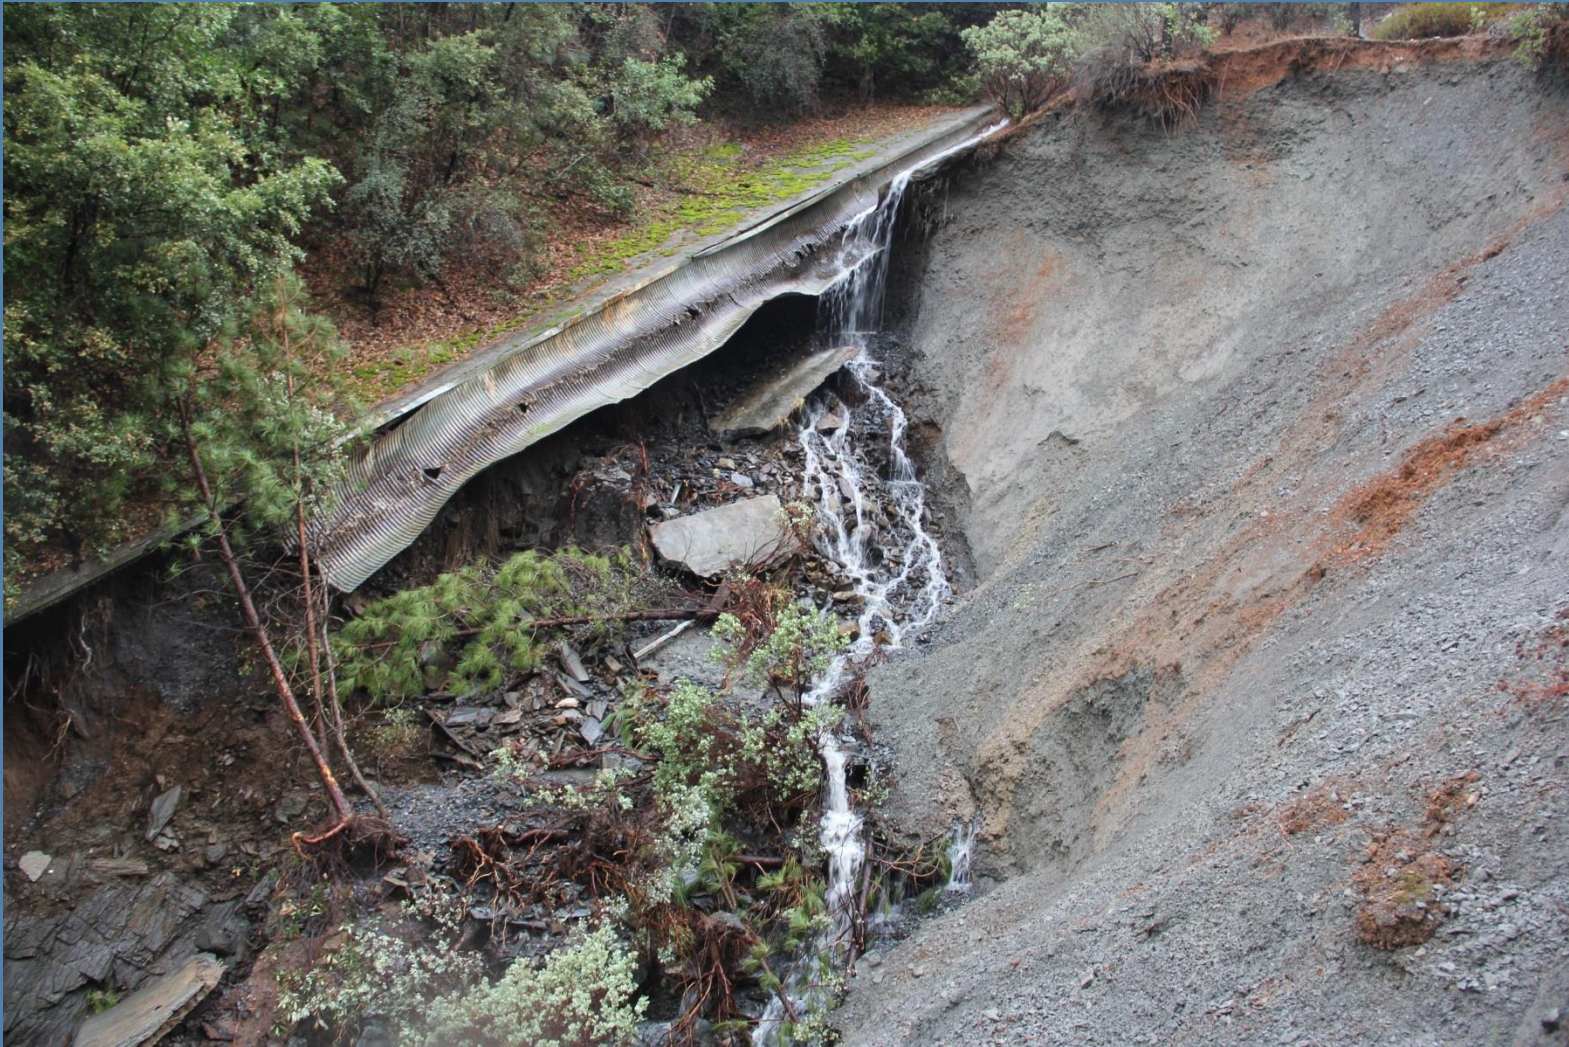
Eroded Section

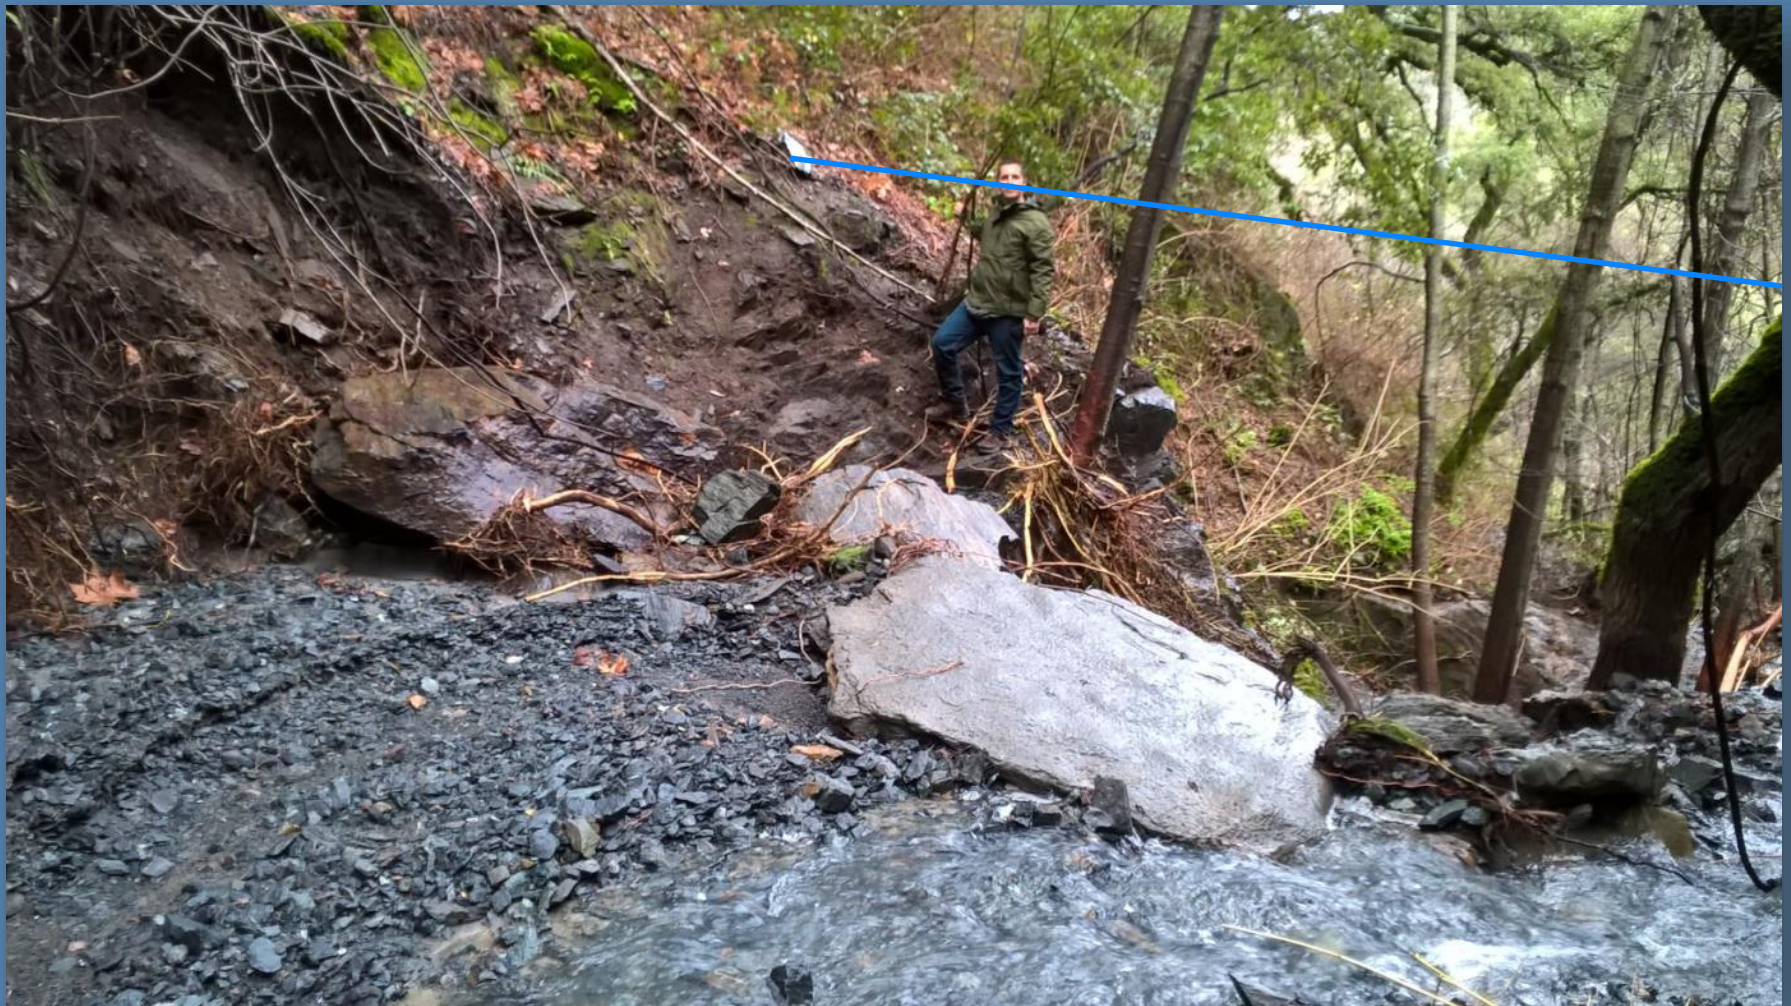
Downstream Deposition

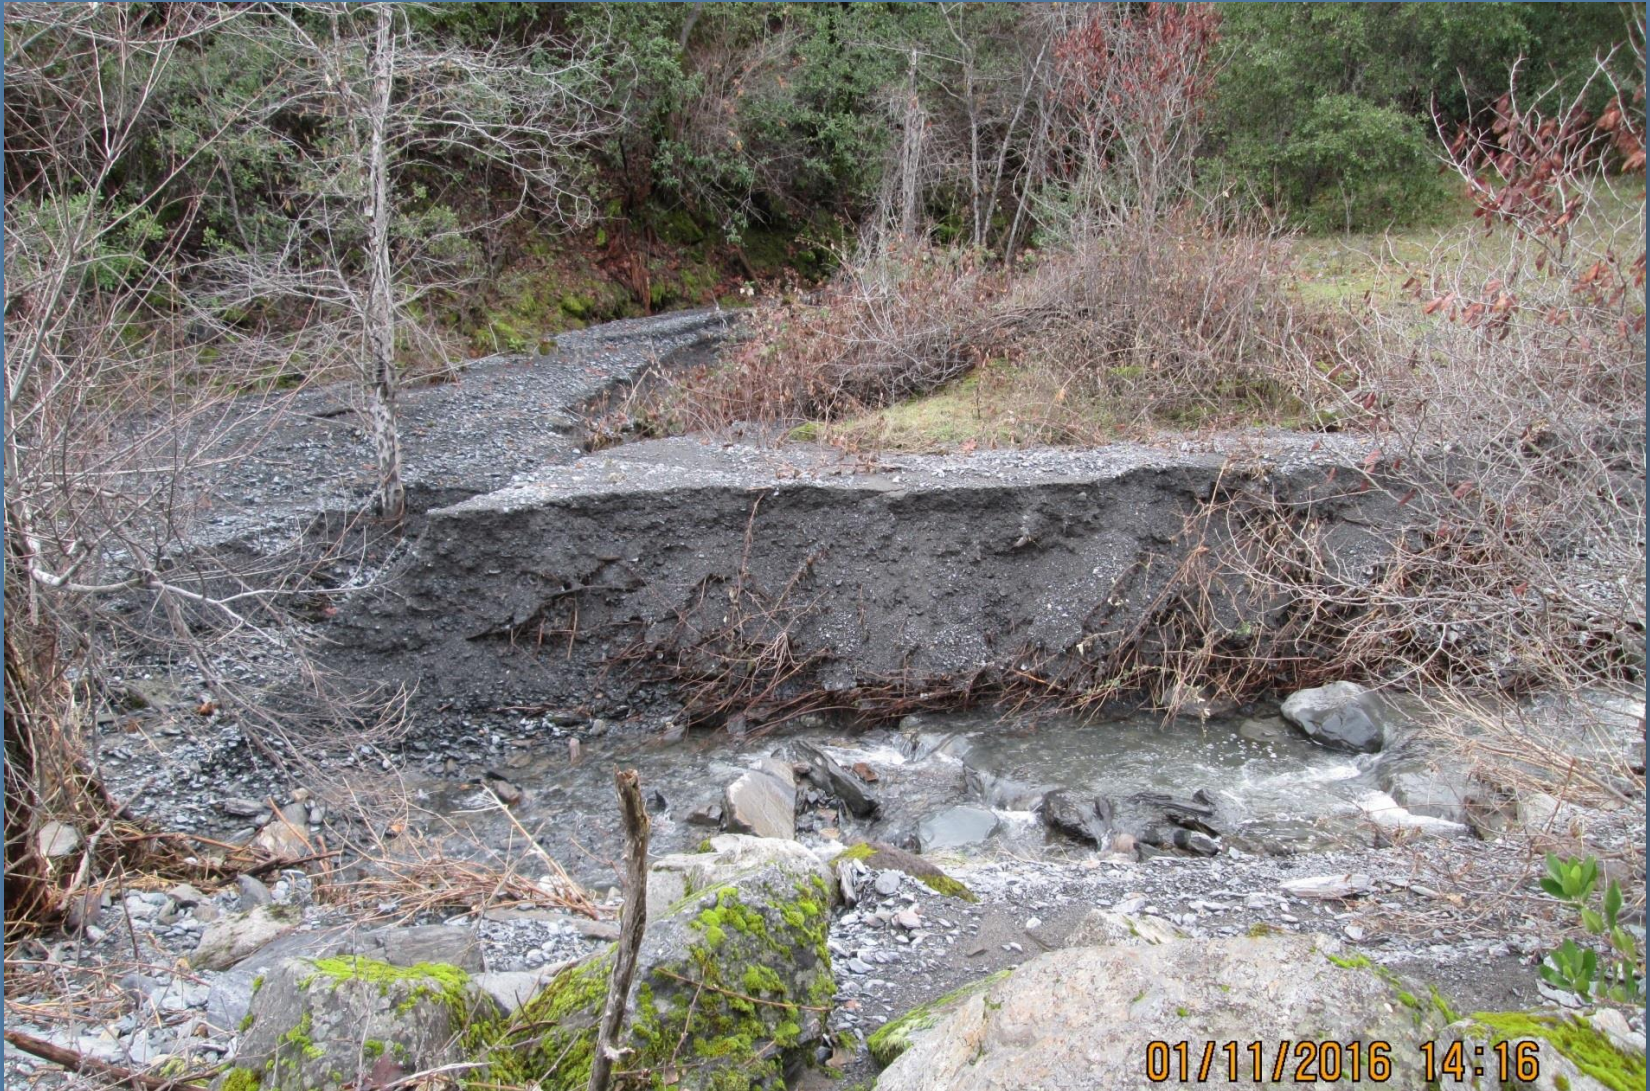
Downstream Deposition

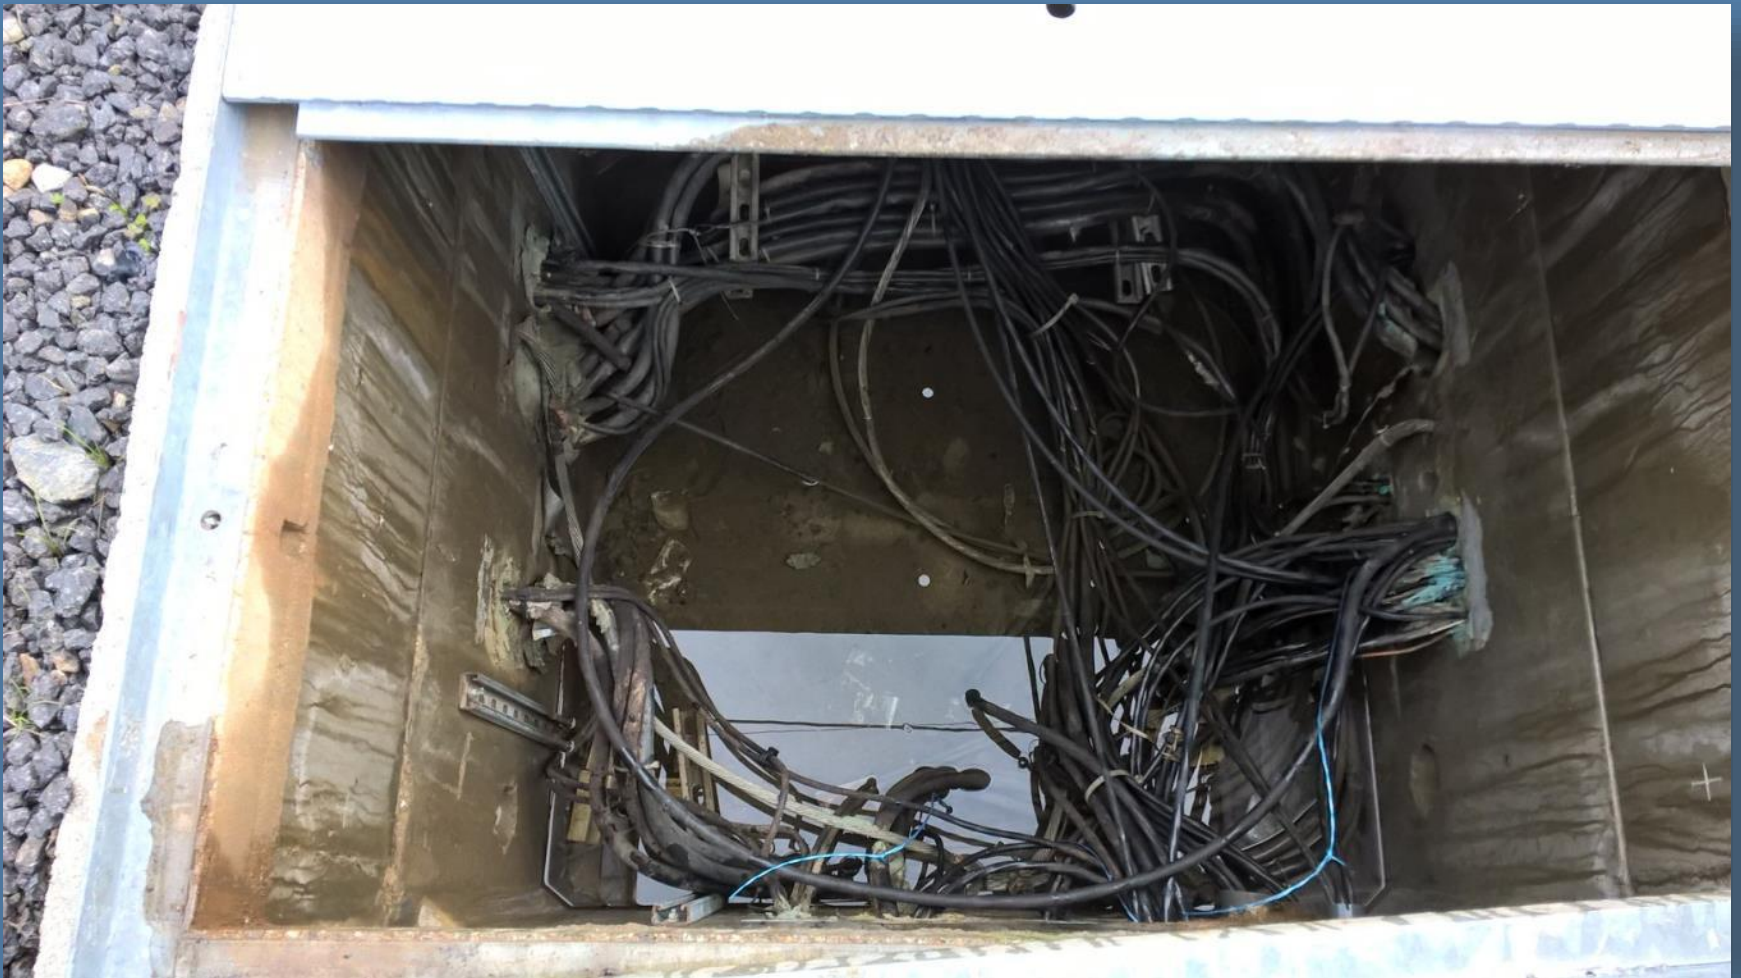
Collierville Powerhouse Flooding

- \$3,000 direct damage to Collierville control room due to flooding
 - “Near-miss” with extensive nearby electrical equipment
- Debris clean-up at Collierville needed
- Environmental impacts to be determined
- Edge of slope failure unstable and unsafe
- Scope of damages and environmental impacts likely to increase without interim water bypass measures

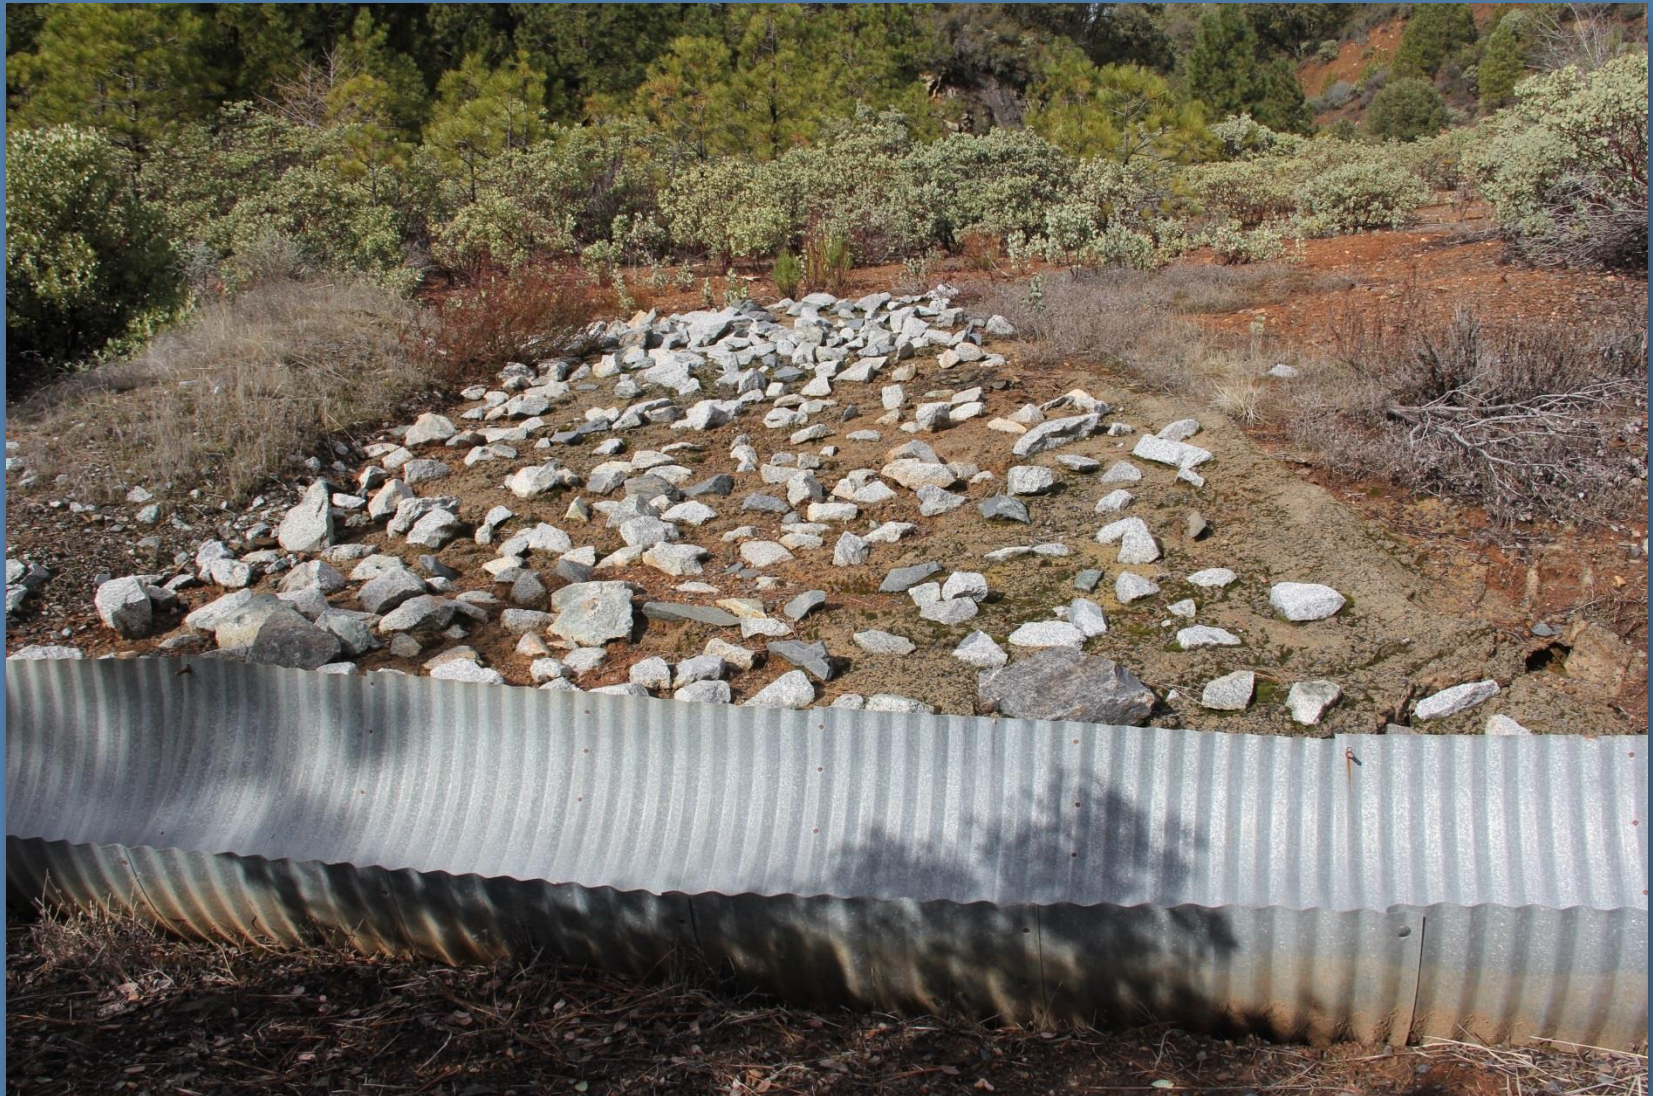
Degraded Drainage Systems

- No observers witnessed failure
 - Catastrophically most likely on December 22nd
- Notified CA Dept. of Fish and Wildlife and Federal Bureau of Land Management
- Original installation included a reinforced concrete toe cap for erosion protection
- Inadequate to withstand hydrostatic loading
 - Initial assessment is water intrusion into Spoils from perforations/plugging of water conveyance features

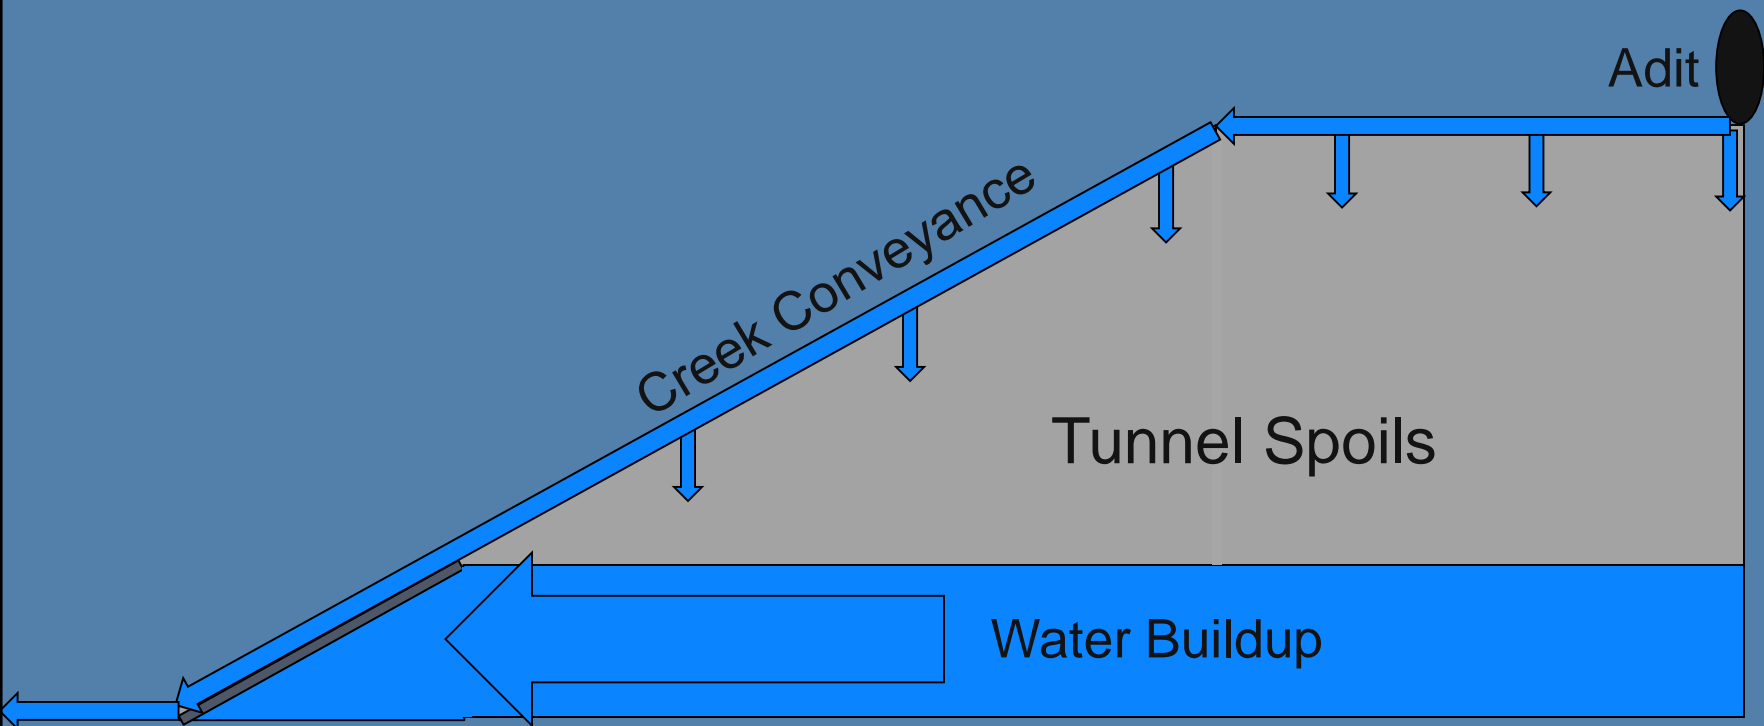
Spoils Failure

- Water bypass scheduled to stem erosion
- Requested Utica Water and Power Authority to avert spillway discharges

- Phase I: Interim site stabilization
 - CEQA Notice of Exemption filed January 27th
 - Negotiated a time and materials contract
 - Control active erosion and minimize impacts of planned repair
 - \$129,200 hybrid lump sum and time/materials contract
 - On-site work planned to begin February 8th
 - Investigating potential insurance claim
 - Initial site visit February 2nd -additional planned
 - Marsh retaining 3rd party engineer

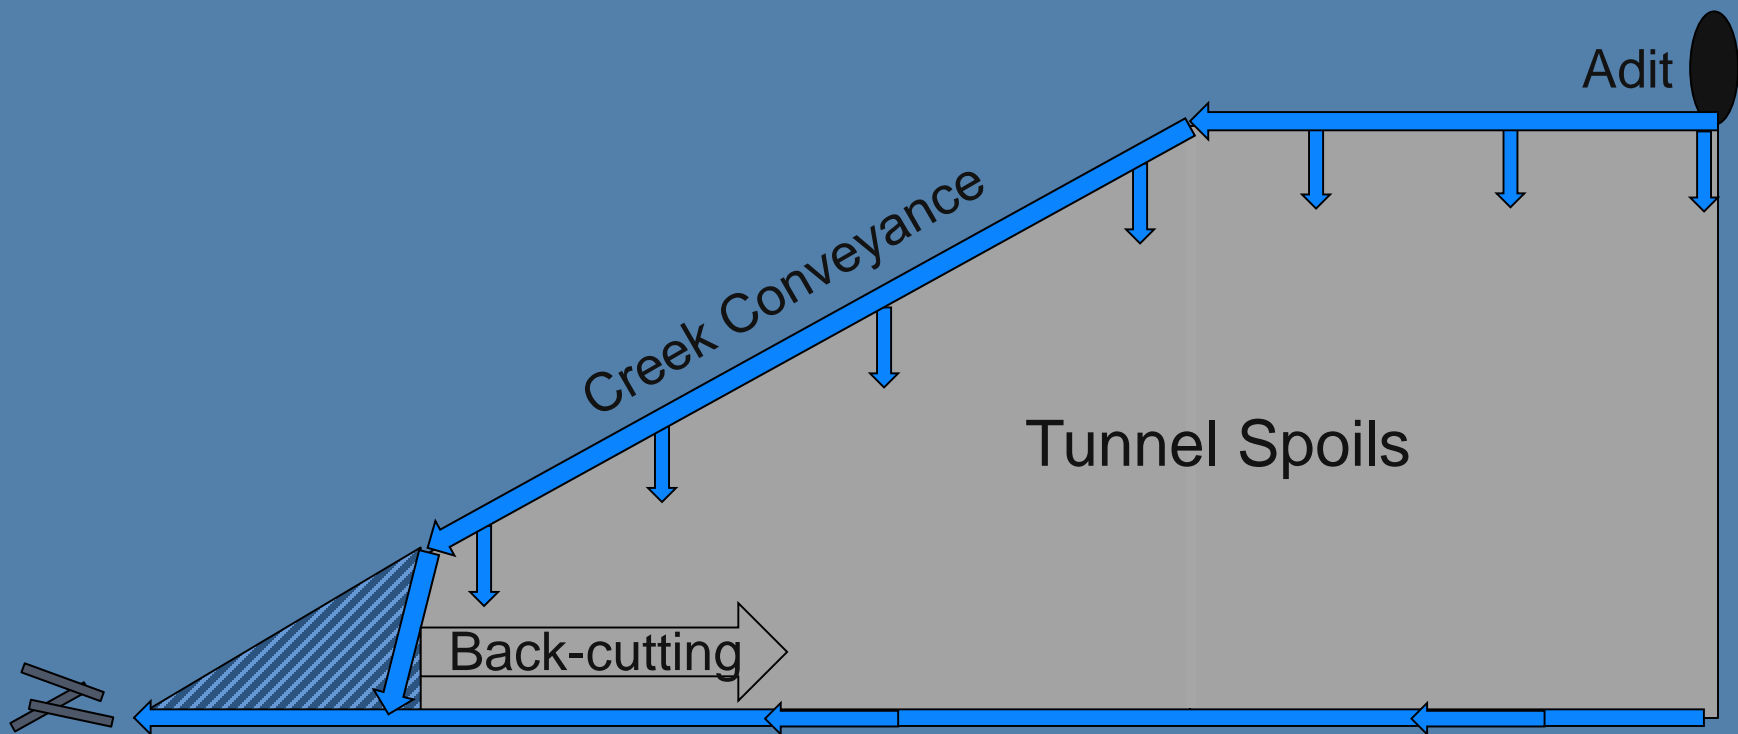
Spoils Failure
