CT1 Alameda Unit 1

Unit 1 Borescope Findings and Staff Recommendation

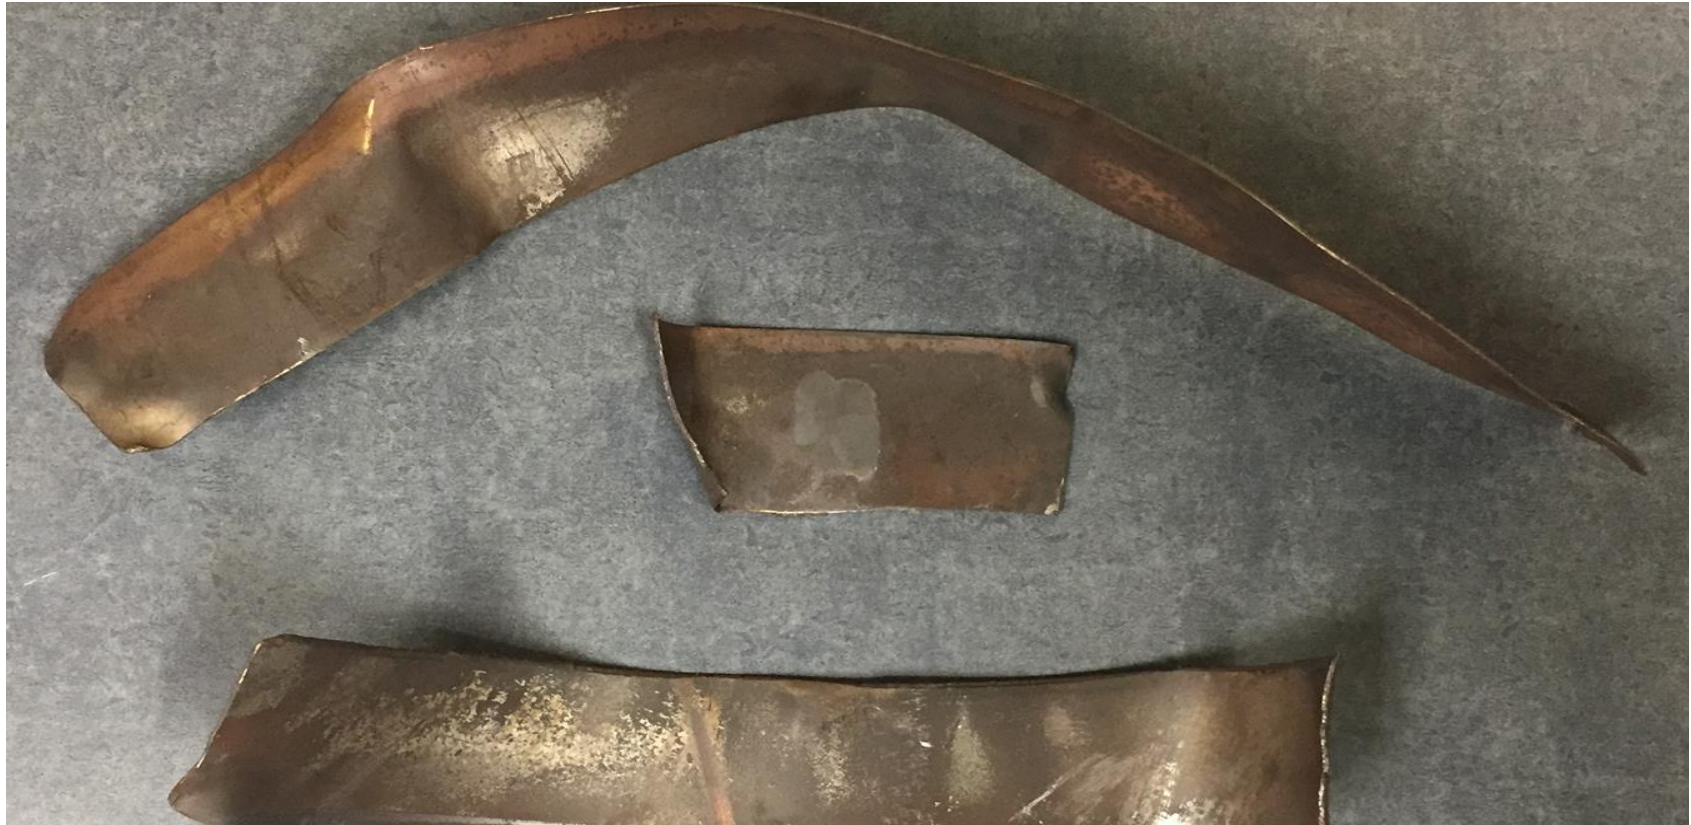
An employee found metal parts on the ground around Unit 1 stack while he was conducting his weekly rounds at facility. Unit 1 was taken out of service and a borescope inspection was conducted.
