# Geothermal Steam Field

## Geo Steam Field P Site Well Casing Deformation

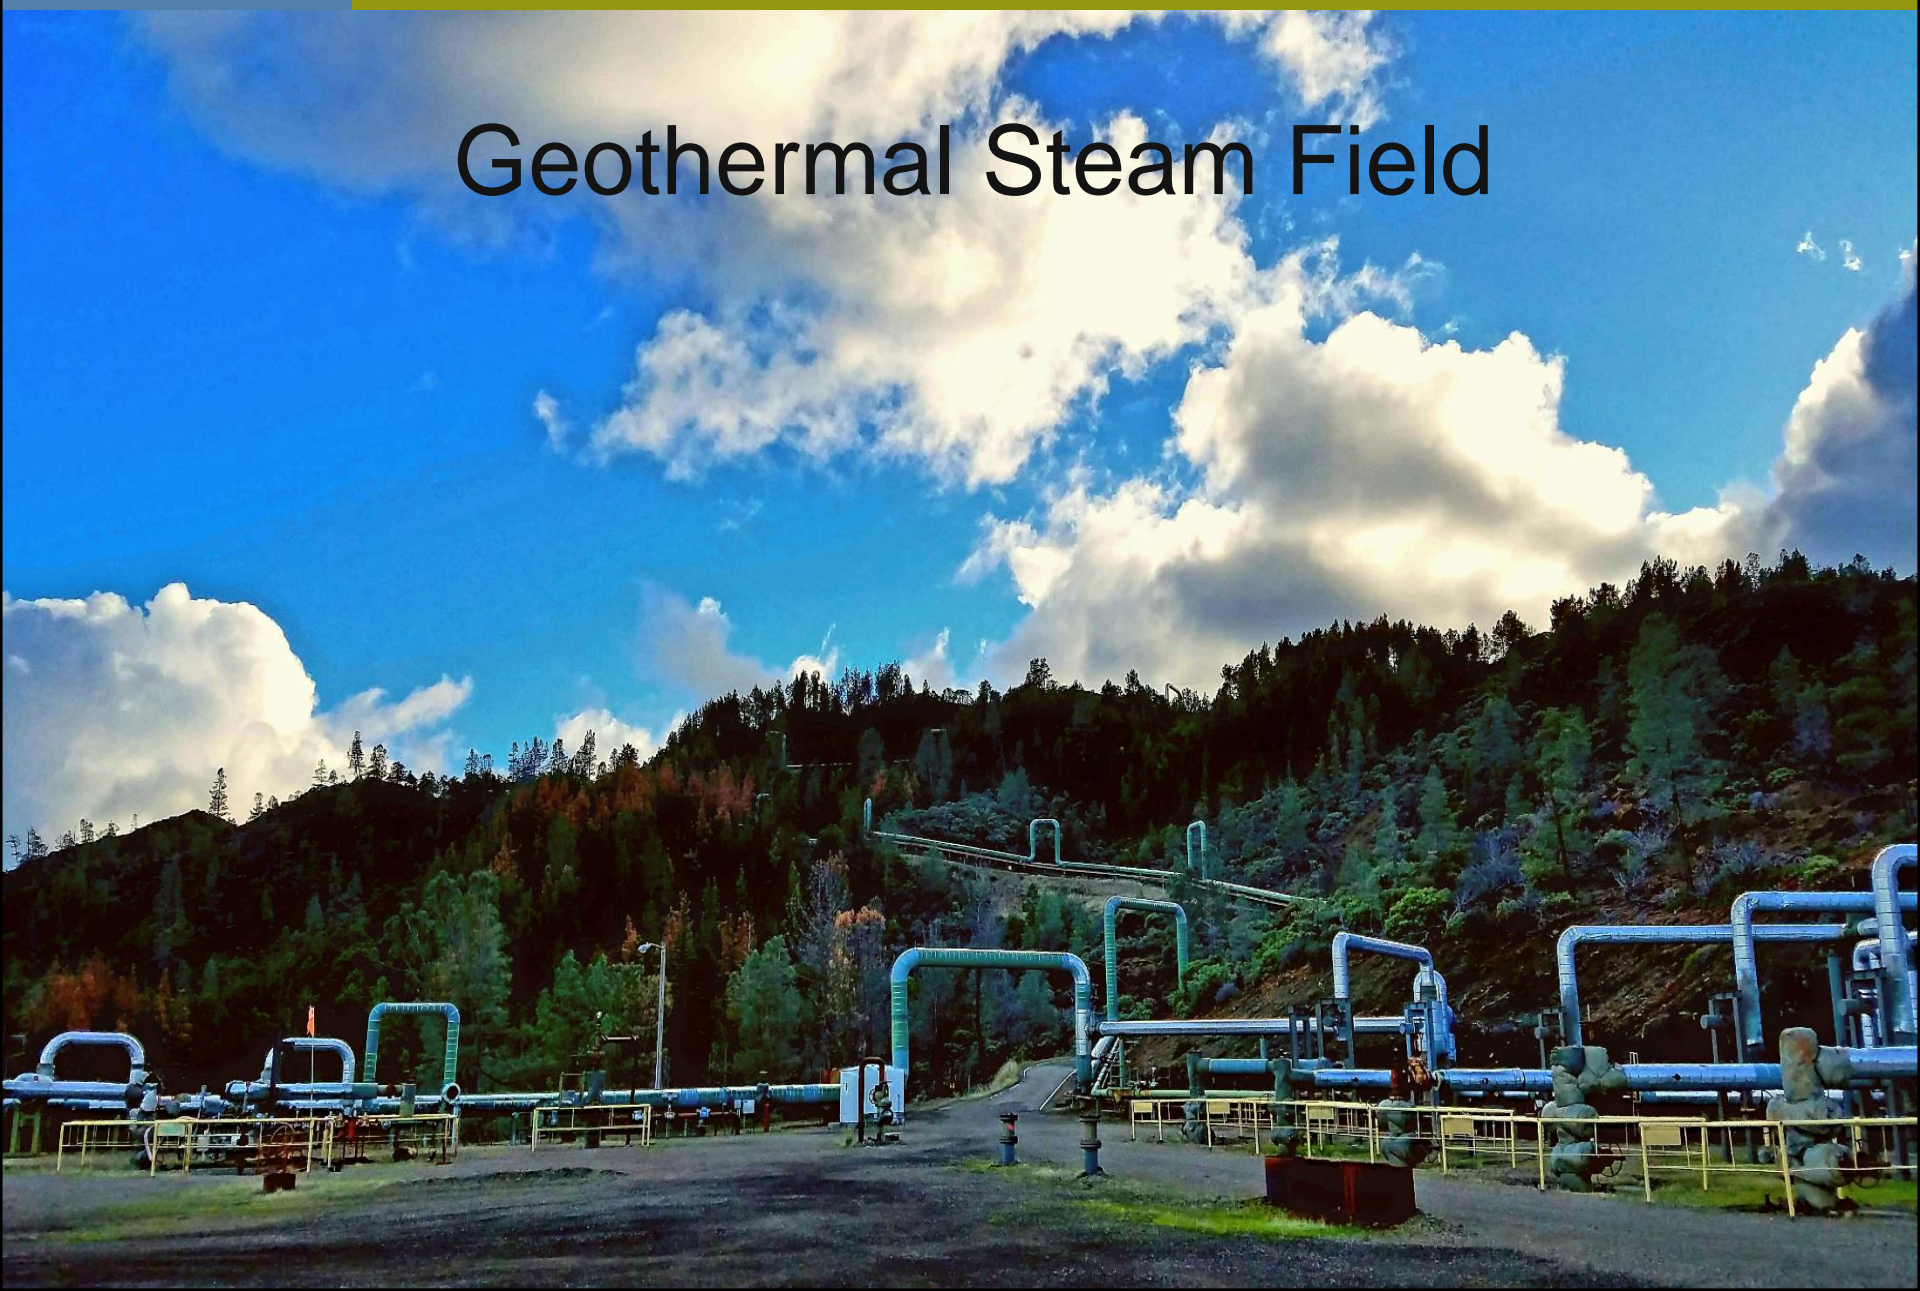
- 2014: Started a spot check on well casing conditions throughout the NCPA Field
- Most of the data did not show significant well casing issues except P Pad

- Data showed the two surveyed P site wells had deformation between 900'-1000'
- At present, the 8 production wells on P-site provide almost 1/3 of the total steam to Plant 2
