Geothermal Steam Field - Well Status

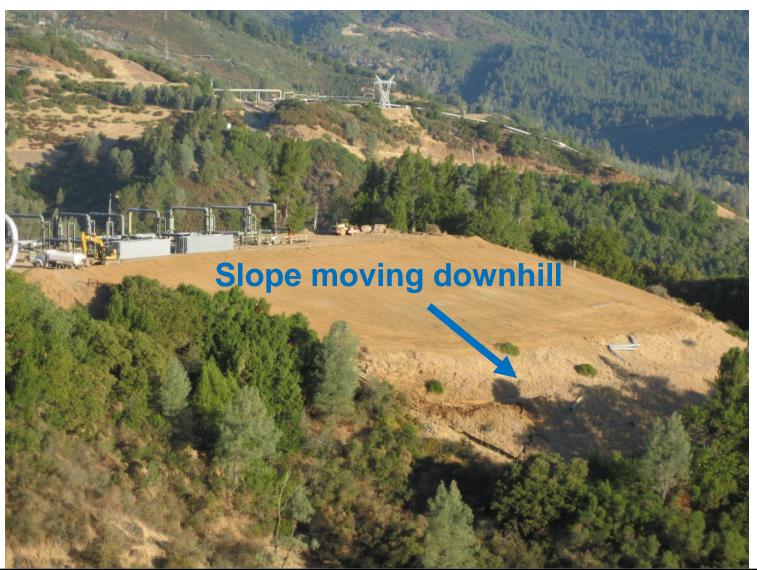
P-Site Well Pad

- P-Site Ongoing well deformation ~ 1000 ft.
- Plan to monitor the wells and develop plans to repair if flow becomes inhibited.
- Injection System Four wells are out of service since 2014.
 - Workover existing well, \$2 to \$6 million
 - Drill new "SLR" well, \$1 to \$2 million
- Maintenance Reserve \$6.2 million to cover drilling and overhauls in FY2019

- Well Workovers are problematic.
 - Greater the damage, less probability of success
- Repair methods
 - Swedge or mill casing, then line with new casing
 - Set cement plug, sidetrack and re-drill
- Workover costs range \$2 to \$6 million
